ASHI Membership #211565
Washington State License #344
WSDA Structural Pest Inspection Lic. #63960
Inspector-Dan Hicks ICN#
Home Inspection Report

July 13, 2015

Recommendation Work Sheet for [REDACTED] of Lynden, for [REDACTED].

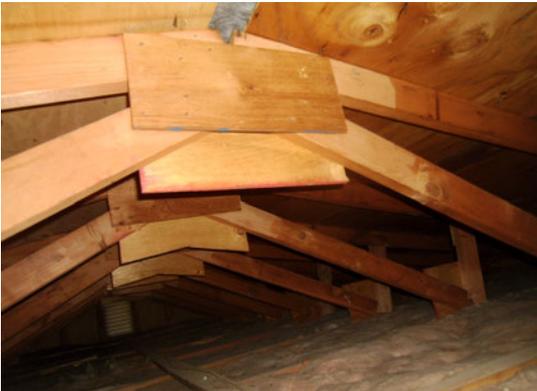
- (1) The garage roof trusses appear to be home made. Sags in the roof and ceiling suggest movement in the trusses. Have a licensed building contractor or a structural engineer further evaluate the trusses and determine if repair or correction is needed, and if this condition will worsen if not addressed.
- (2) The garage lacks a required fire separation. The fire separation walls and or ceiling consist of wood covering. The house/garage door is not fire rated. Have a licensed building contractor provide the required fire separation.
- (3) The basement bedroom windows do not meet the minimum egress standards. The openings are too small. Have a licensed building contractor replace the windows with the required egress sized windows.
- (4) Numerous windows in the house are in locations that would require them to be tempered.

Home made trusses in garage

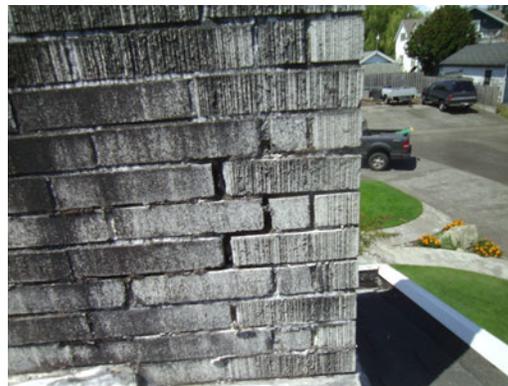
- (1) The main fireplaces are not in use. The upper chimney exhibits deteriorating mortar joints. Consult with a certified chimney sweep for a further inspection and repair before using the fire places.

Upper chimney mortar deterioration
