ASHI Membership #211565
Washington State License #344
WSDA Structural Pest Inspection Lic. #63960
Inspector-Dan Hicks ICN#
Home Inspection Report

October 17, 2015

Inspection Report Summary of [REDACTED] of Ferndale, for [REDACTED]

[REDACTED] of Ferndale is a wood framed, (approx. 1038 square foot) rambler that was built in 1969 and has an attached single car garage.

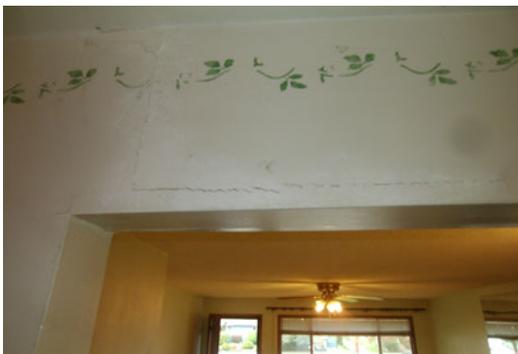
An interior wall in the house (between the kitchen and the living room) exhibits some stress fractures, a sagging ceiling and a sloping floor. It appears as though a support footing in the crawlspace may have settled causing the floor supports to settle as well. Further investigation will be required by a specialist and a repair may be required.

Interior wall fracture

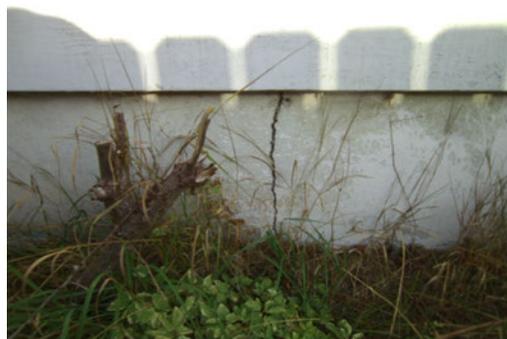
The house foundation exhibits a significant crack on the south wall which will require a building contractor or a structural engineer to be observed and determine if a repair will be necessary.

Foundation crack

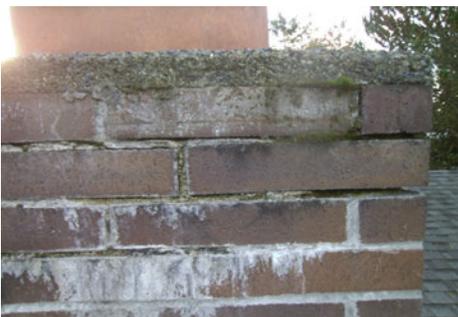
A damper was not observed at the fireplace, and the upper chimney mortar is in deterioration and will require repair. A professional chimney sweep should be consulted to further inspect the fireplace before it is used.

Deteriorated chimney brick

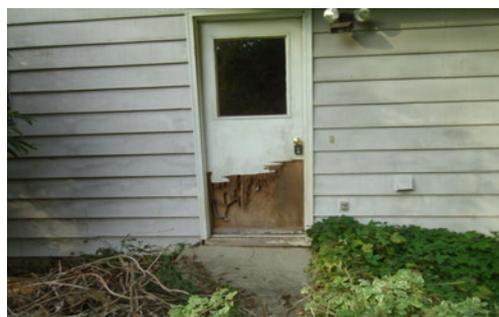
Damaged rear door

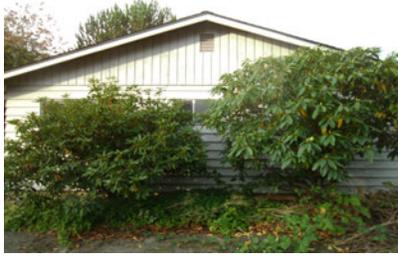
Vegetation on structure

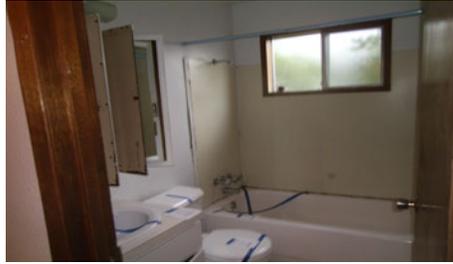
The bathrooms and the kitchen have been winterized. Without the water turned on, no plumbing inspection took place at this time.

Winterized bathroom
